Damages during February, 6-24 2017 Çanakkale earthquake swarm

Ramazan Livaoğlu¹, Mehmet Ömer Timurağaoğlu¹, Cavit Serhatoğlu¹, Mahmud Sami Döven²

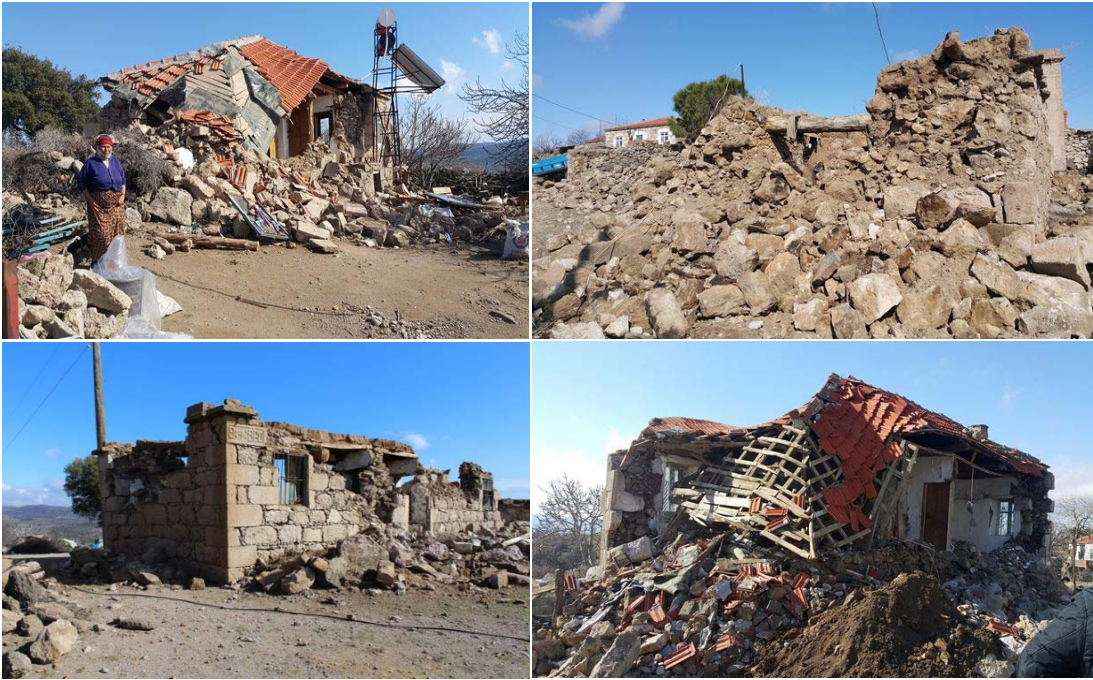
Failure mechanisms observed during the 2017 Çanakkale earthquakes swarm were also observed in other recent moderate earthquakes in Bala (ML=5.5), Doğubeyazıt (ML=5.1), Dinar (ML=5.9) and so on (Tezcan, 1996; Bayraktar et al., 2007; Adanur, 2008; Ural et al., 2012). Adanur (2010) showed that based on the investigations after 20 and 27 December 2007 Bala (Ankara) earthquakes, masonry buildings were built in three types in the affected area: (1) stone masonry buildings with walls made of natural shaped stones, (2) stone masonry buildings with walls made of cut stones, and (3) mixed masonry buildings with walls made of masonry materials like stones and mud bricks, stones and bricks, or stones and briquette. From all, a total of 945 buildings were heavily damaged or collapsed in Bala. Bayraktar et al. (2007) reported that 1000 buildings were affected from the earthquake in Doğubeyazıt. Similar to the above-mentioned studies, thus far, experiences from such moderate earthquakes in rural areas of Turkey have shown that even low-moderate earthquakes may cause significant damages on non-reinforced masonry structures (Fig. 16). This type of construction is among the most vulnerable type of buildings during an earthquake. Even under moderate lateral forces, such a masonry structure is damaged or collapsed due to lack of shear strength, improper interlocking mechanism and/or poor bonding between stone-stone or stone-mortar. In this case, shear failure is

unavoidable in the planes forming diagonal cracks along the wall due to workmanship defects. Furthermore, when the wall is not designed with any engineering rule in mind, catastrophic and rapid collapse occurs in out-of-plane bending mode.

5 **Figure 16: Examples of totally collapsed structures from Ayvacık, Çanakkale 2017 earthquake swarm**

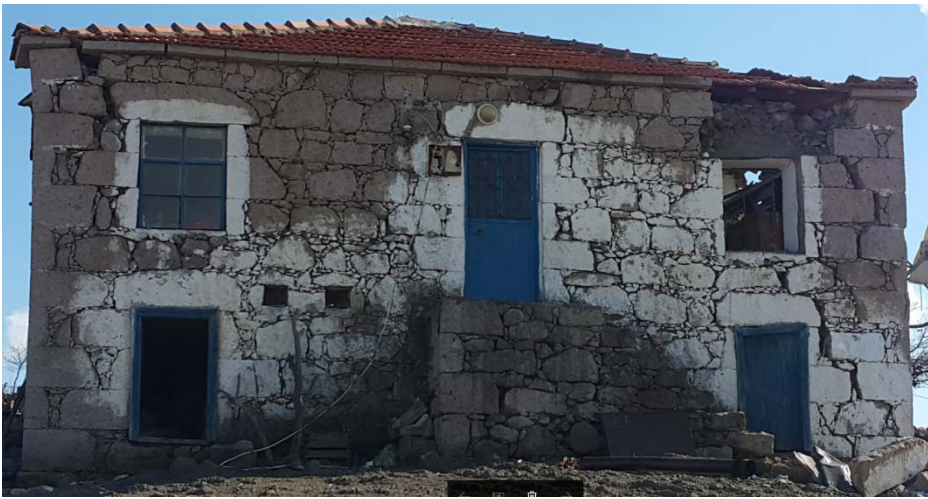
10 In the rural areas of Turkey, the construction of dwellings is done by the owner–dweller with the help of craftsmen who live in the area but are not full-time builders. These builders often learn their trade via apprenticeship. Hence, they have their own tools and do not follow any scientific rules on the site, as a result, an outdated or faulty construction technique can stay alive in a small region, and construction becomes highly similar between the dwellings. For example, during field observations, it was understood that even thick mortar or mud was not used as binding agent between stone or masonry units in almost all
15 damaged houses. Figure 17 is a striking example of heavy damage during earthquakes due to lack of mortar among stones. After a few mild earthquakes this masonry dwelling became unstable.

Figure 17: An example of a damaged dwelling due to inadequate interlocking

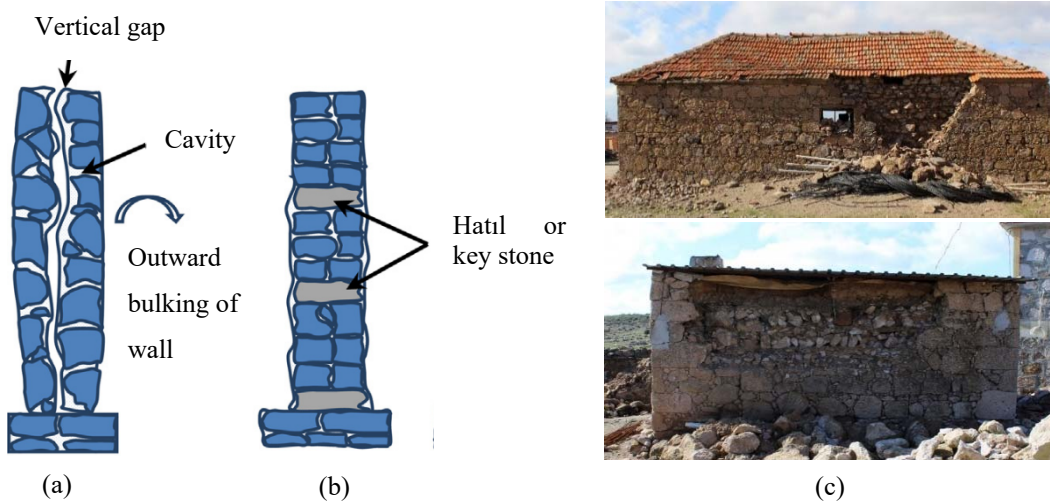
Another damage type observed in the region is outward bulking of walls, which is caused by interlocking deficiency. The reason of this deficiency is the vertical gap between stones creating wall thickness as shown in Fig. 18. In order to prevent this damage, horizontal elements such as ‘hatıl’ or key stone, which provide integrity to masonry walls, can be vertically used in specific intervals. The key stones or ‘hatıl’s can provide limited resistance to lateral seismic loads, and thus probably prevent the out-of-plan failure on some part of masonry walls.

10 Figure 18: Schematics of (a) conventional wall section without through stone, (b) wall section with key stones (Sharma, 2016), (c) damages observed in the region.

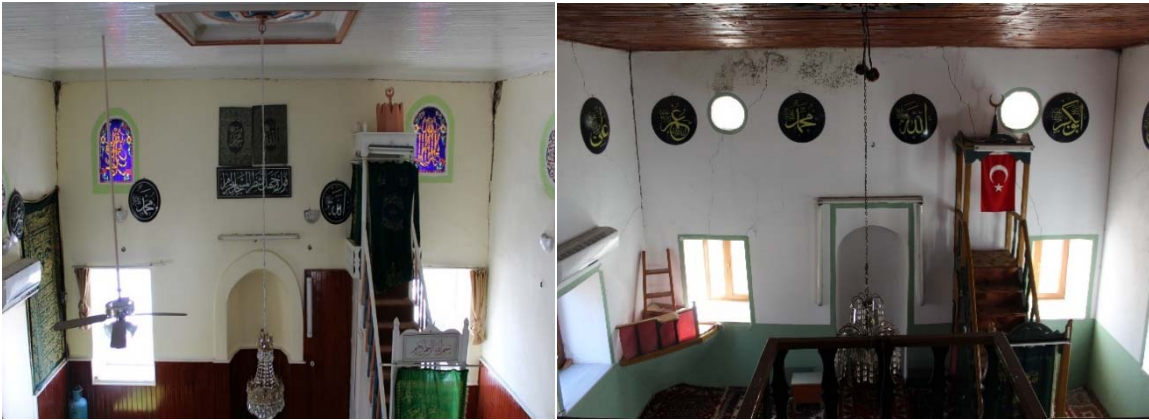
Another interlocking damage type is observed at the intersection of perpendicular walls (Fig. 19). One of the walls acts out of plane while the other remains very stiff in plane, resulting in inevitable cracks. This type of damage can either result in gaps developing between the in-plane and out-of-plane wall or vertical cracks may occur in the out-of-plane wall (Tolles et al. 1996). Further stages of this damage may result in out-of-plane failure of gable-end wall. To avoid intersection damage, the interlocking in the corners between perpendicular walls should be properly designed against lateral earthquake forces.

Figure 19: Observed damages at intersection of perpendicular walls

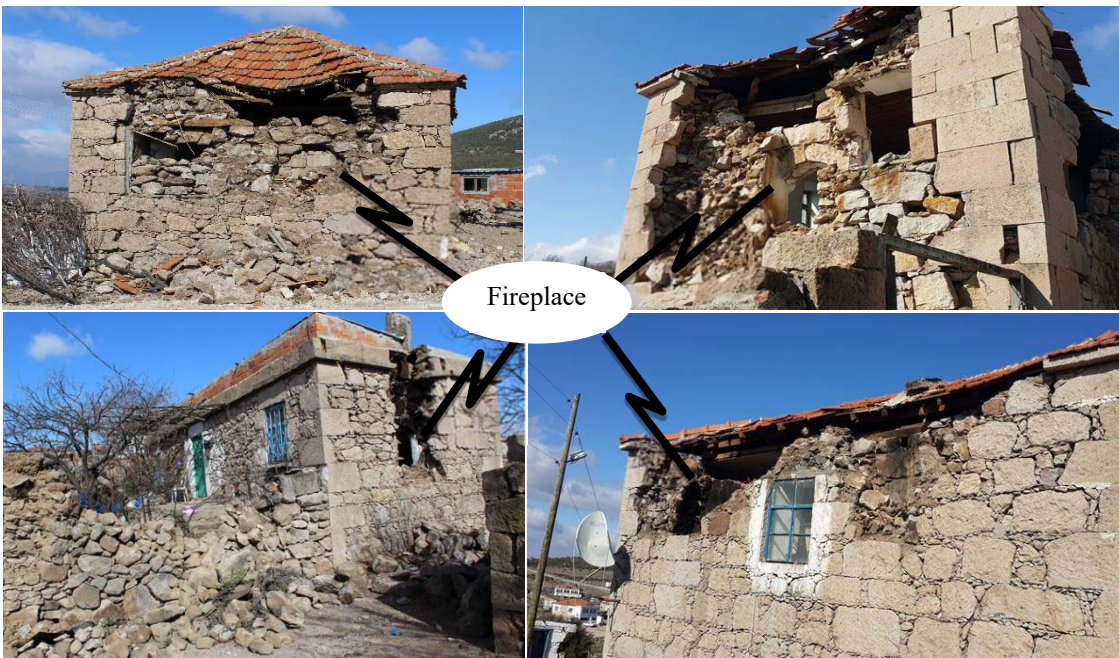
10 The design process of masonry buildings needs more regularity compared to other supporting systems, because resisting system must have continuity and regularity in order to take the stress of the shear forces due to the earthquake. In rural areas, however, traditional fireplaces have been used in buildings, and they are built within the wall by decreasing the wall thickness or curving the wall outward. In such a case, irretrievable damage is inflicted on the wall because of decreasing shear resistance (Fig. 20). This damage type was observed in different masonry structures in the site. Different cases such as cut stone masonry, 15 stone with plaster, and stone without mortar can be seen in Fig. 20. The common damage type is most likely caused by the lack of craftsmanship or traditional habits.

Figure 20: Examples of out of plane collapse due to wall cavity

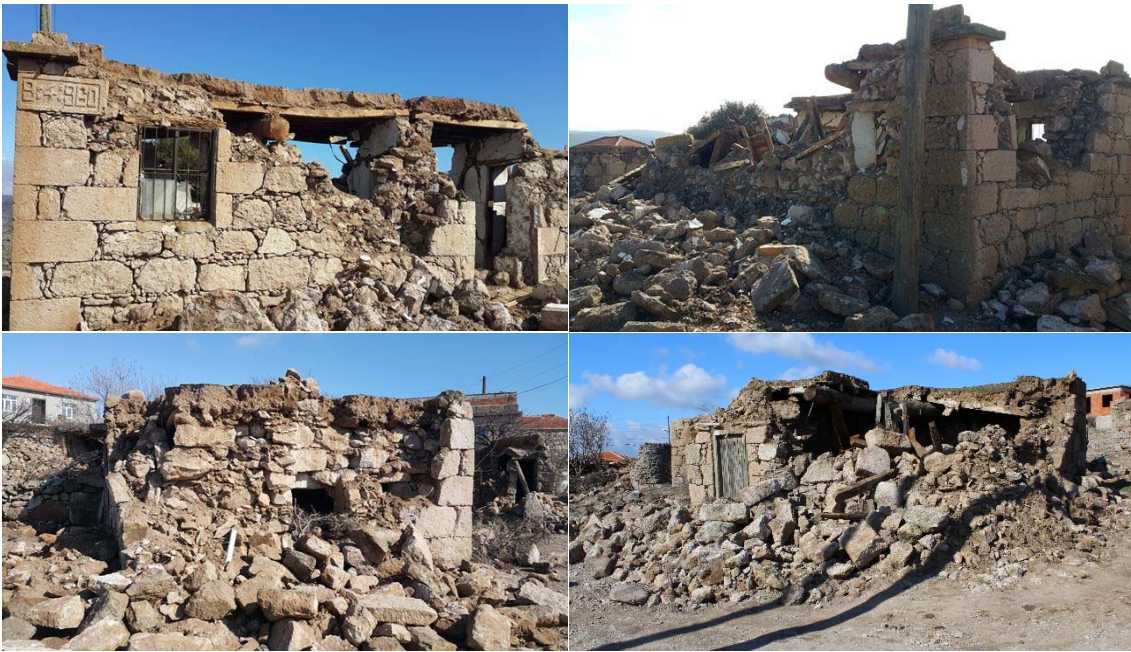
Another important cause of damage is the roofs made from a thick and heavy layer of mud spread upon wooden logs (Fig. 21).

5 This technique is widely used in certain parts of Anatolia where timber is increasingly scarce. These heavy earth roofs are generally hardened by spreading soil with a cylindrical stone. The roof must be thickened more and more over the years to make it more durable against water leakage. Consequently, heavier roofs exert larger shear forces during an earthquake. In the investigated area, the roofs were either supported by beams and indirectly by walls or beams of the inner structure, and the columns were round or sub-round in cross-section, and the trunks were without the barks. This made it virtually impossible to

10 obtain good connections and bearing surfaces between the beams. Such beams were prone to rolling off during motions induced by earthquakes. Moreover, the round ends of the beams exerted loads (to an excessive degree) on the supporting walls beneath them, and resulted in the collapse of the earth roof or walls.

Figure 21: Examples of collapse due to heavy earth wall-roof collapse

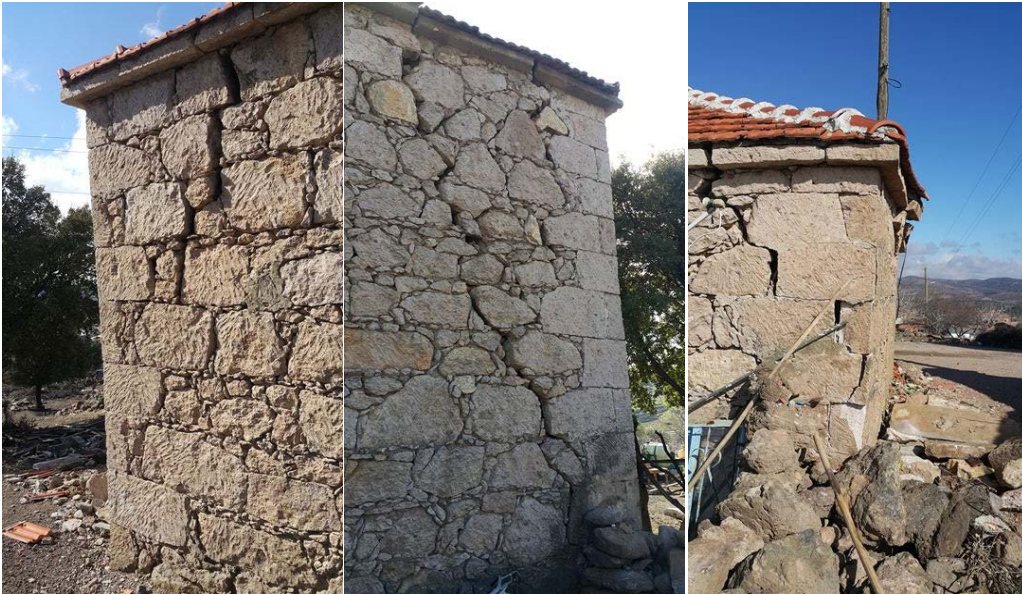
Many weak masonry walls without mortar had diagonal or inclined shear cracking as a result of cyclic shear forces exerted during the earthquakes (Fig. 23). But this diagonal shear cracking does not necessarily lead to total collapse. However, collapse may be inevitable if the triangular wall blocks on each side of a full diagonal crack become unstable by substantially losing their interlock or friction resistance along the cracks (Fig. 24). Similar failures have previously been reported around the world (Ural et al., 2012; Klingner, 2006).

Figure 23: Examples of diagonal shear cracking

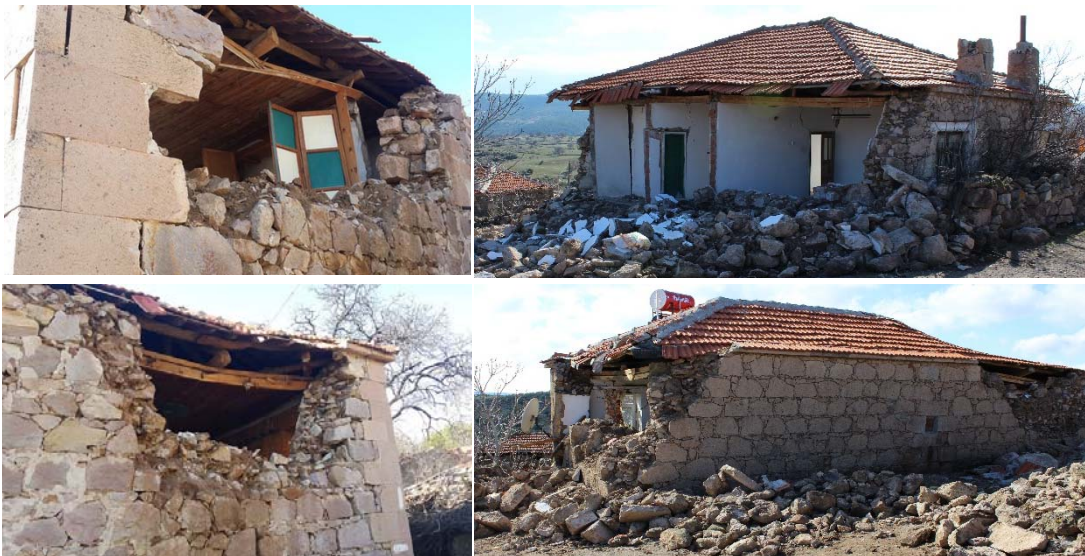
In many cases, distinctive diagonal or inclined cracks were observed in load-bearing window piers or walls with low width-to-height ratios as a result of inadequate shear resistance (Tomazevic, 1999). While bending and shear forces created by a moderate earthquake can be easily resisted by reinforced-masonry with lateral and horizontal elements such as RC or timber (Fig. 22), the dwellings made from stone with no mortar cannot resist these forces. This construction defect causes in-plane failures by means of excessive shear force or bending or out of plane failure by bending depending on the aspect ratio of the unreinforced masonry elements.

10 Figure 24: Out of plane failures due to improper wall thickness and/or height-length ratio
