The Mosaics of the Roman Villa of São Simão, Penela, Portugal

Sónia VICENTE – Ana Luísa MENDES*

Abstract

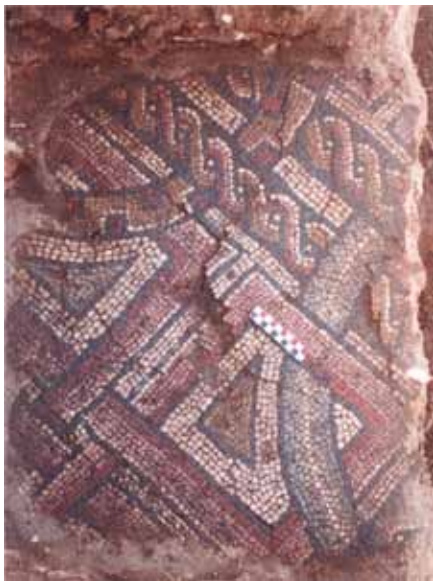
Figure 6
Photographic record of “mosaic 1”.

The description is made by Miguel Pessoa on the occasion of the construction of the wall, in 2001, and published in the article “Contributo para o estudo dos mosaicos romanos no território das *civitates* de *Aeminium* e de *Conímbriga*, Portugal” in *Revista Portuguesa de Arqueologia*, vol. 8, no. 2, 2005 (Figs. 6-7).

“This is a mosaic with a reticulated pattern of square bands decorated with guilloche, showing an interpenetration of quadripartite squares, decorated in the center with a cross of interlaced pairs of bands and expanded circles, decorated with either embattled dents or shaded bands as intersection motifs, which determine irregular octagons with four sides concave. Density of about 200 *tesserae* per dm² (Blanchard 1973: n°330; Décor I: pl.168b; Décor II: 40)”.

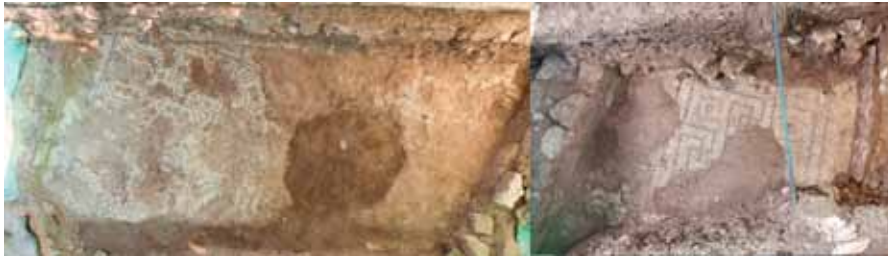
Figure 9
Photographic record of “mosaic 3”.

Does it suggest the possibility of a *triclinium* room? Due to the dimensions that it presents (width of 8, 70 m) and also due to the layout of the mosaic panels (Fig. 9).

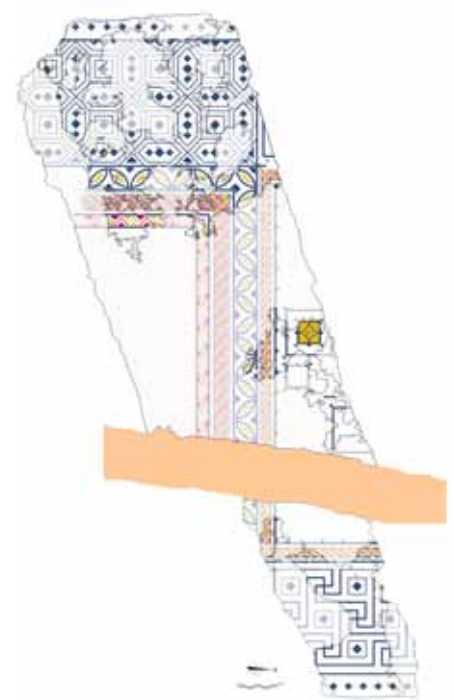
Figure 10
Graphical reconstruction of the pavement of “mosaic 3”.

According to the presented graphic diagram (Figs. 10, 11), the following description is presented:

Nº 1 and 1a – White fillet with non-continuous oblique squares. These fillets appear to be the lateral limits of the room (Décor I: 31 pl.5a)

Nº 2 – Outlined orthogonal pattern of irregular octagons, adjacent and intersecting on the shorter sides (Décor I: 260 pl.169a). In the center of the octagon, the central square is filled with a lozenge. The interior of the hexagons is filled with bichrome lozenges.

Nº 3a – Polychrome row of tangent semicircles formed of two tangent spindles, forming alternately inverted thorns, the colours counterchanged, with ensconced serrated triangles (Décor I: pl. 93 pl.45g variants);

Nº 3b – Polychrome four strand guilloche on a black ground (Décor I: 123 pl. 73 b, c, d, e);

Nº 3c – Row of countercurved arc with alternating colour (red / yellow) in a frame (Décor I: 99-10 pl. 49 to 51).

Nº 4 – A damaged panel where it is possible to understand that it has a two-strand guilloche (Décor I: 120 pl. 70 h, i, j) in the frame of the central panel and, in the interior, squares filled with other tipped lozenges. It’s polychrome.

Nº 5 – Pattern of spaced swastika-meander with single returns and squares (Décor I: 300 pl.190a).

Measures: length 8, 70 m x width 2, 30 m

Material used: White, black, yellow, red and pink limestone *tesserae*

Density: 59 *tesserae* per dm²

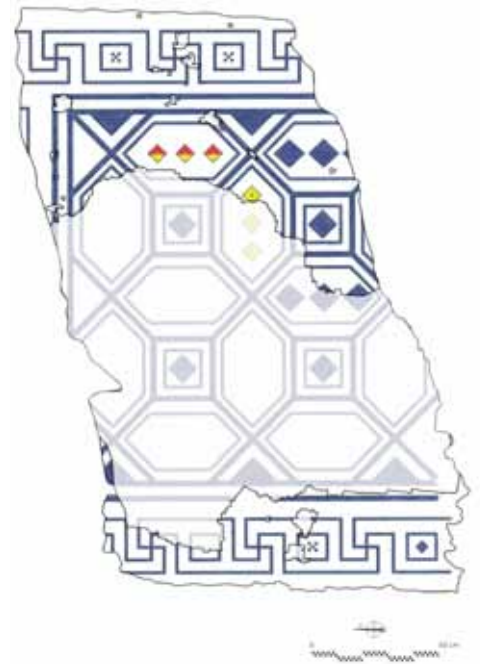
Figure 13
Graphical reconstruction of the pavement of "mosaic 4".

According to the presented graphic diagram, the following description is presented (Figs. 13, 14):

Nº 1 and 1a – It features a swastika-meander of spaced single-returned swastikas with a square in each space; inside the square, there is a crosslet; on the opposite side of the corridor, the same motif with a variant inside the square: lozenge (Décor I: 81 pl. 38a).

Nº 2 – Central corridor motif: outlined orthogonal pattern of irregular octagons adjacent and intersecting on the shorter sides, forming squares and oblong hexagons (Décor I: 260 pl. 169a). In the centre of the octagon, the central square is filled with a lozenge. The interior of the hexagons is filled with bichrome and polychrome lozenges, of irregular size.

Measures: length 2.50 m x width 1, 50 m

Material used: White, black, yellow and dark pink limestone *tesserae*

Density: 104 *tesserae* per dm²

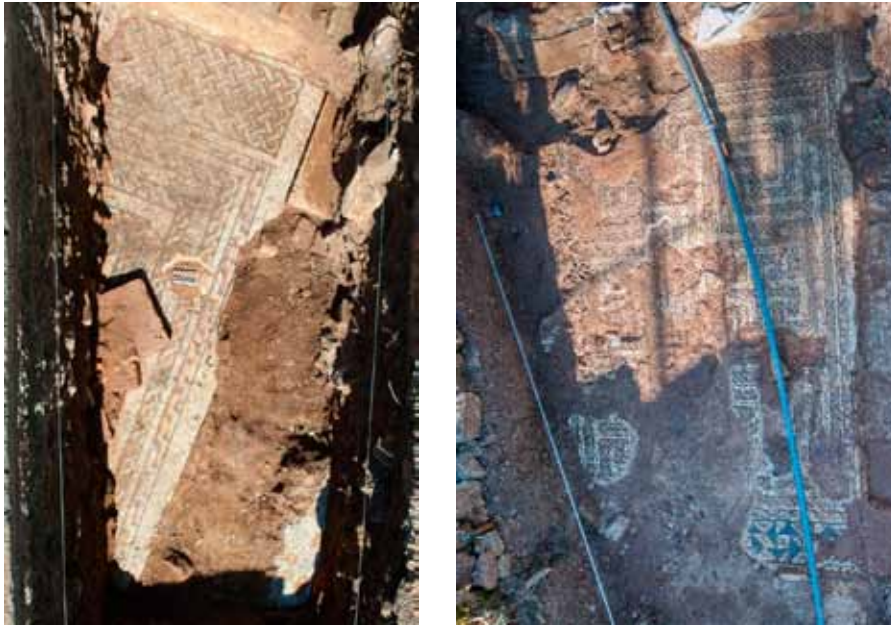
Figure 15a
Photographic record of “mosaic 5”
found in 2015.

At the present time the identification of its function is not possible (Figs.15a-b). It possible to verify that the pavement had already had many restored areas in its time through the rectification of gaps with simpler materials, like *opus Signinum*, confirming this *Villa's* ample diachronic occupation. As a consequence of the restoration works, it would be possible to maintain the use of the compartment regardless of the aesthetic appearance.

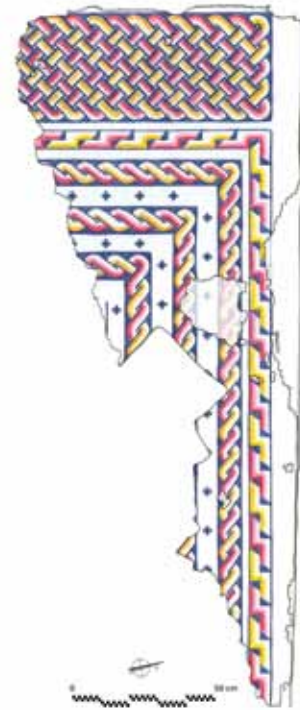
Figure 16
Graphical reconstruction of the
pavement of “mosaic 5” found in 2015.

According to the presented graphic diagram, we suggest the following description (Figs. 16-17):

Polychrome mosaic: it presents a band of white *tesserae* close to the wall.

Nº 1 – Polychrome intersection or ten-strand guilloche (Décor I: 123 pl. 73f)

Nº 2a – It has alternating bands of polychrome rows of tangent semi-serrated right-angled-Z pattern on a black ground (Décor I: 74 pl. 32h);

Nº 2b – Monochrome band with white tesserae (Décor I: 26 pl.1y);

Nº 2c – polychrome band with two-strand guilloche on a black ground (Décor I: 120 pl. 70h,j);

Nº 2d – Black crosslet band on a white ground (Décor I: 30 pl. 4b)

Nº 2e – The centre of this mosaic has a pattern of staggered bands of swastika-meander alternately with double returns and recessed reverse returns in simple guilloche, on a black ground; (Décor I: 294 pl. 87b); it is a variant; on a white ground band with black crosslet. (Décor I: 30 pl. 4b)

Nº 3 – Row of tangents wheels of triangles (forming squares, parallelograms and triangles), it's polychome (Décor I: 68 pl. 29g); it is a variant.

Measures: length 5,10 m x width 4,20 m

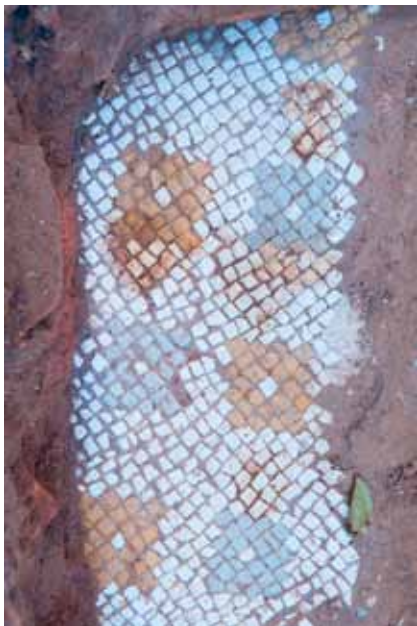
Figure 18
Photographic record of “mosaic 6”.

According to the presented graphic diagram, we suggest the following description (Figs. 18-20):

Alternating serrated squares, in yellow and blue colour, on a white ground. (Décor I: 181 pl. 113f);

Measures: length 0,73 m x width 0,20 m

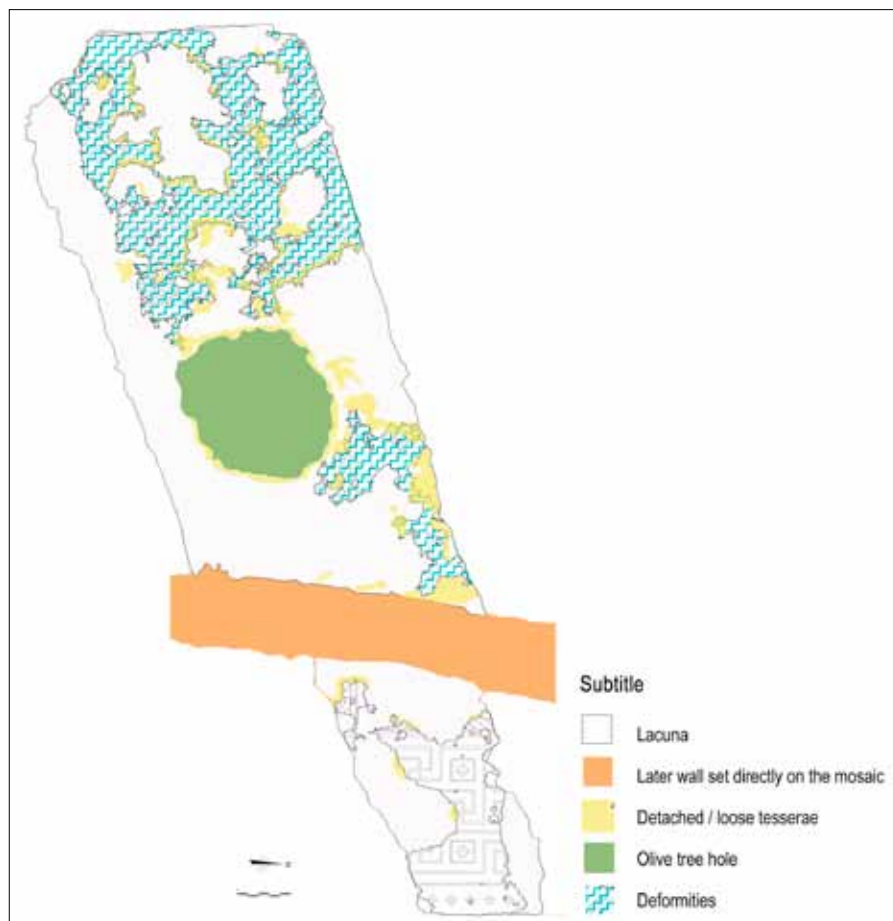
Figure 21
Mapping of the state of conservation, extension and damages of “mosaic 3”.

“Mosaic 3” is in a poor state of conservation (Fig. 21). This pavement presents several deformities (blistering / concavities) and a large number of detached as well as loose *tesserae* (Fig. 22), in addition to several gap areas.

The distance it is from the surface is very short which exposes it to all the trepidation associated with a fully functioning road.

The construction of the ditch for the installation of water pipes, the road construction and the expansion of the Chapel's churchyard have been the factors with the greatest impact on the state of conservation of this pavement.

A great gap area is still visible, resulting from the planting pit of an olive tree that adorned the churchyard.

The identification of a wall built over the mosaic pavement reflects the later occupation of that space and a readaptation of what would seem to be a single compartment in the Roman period and that is now divided into two distinct areas.

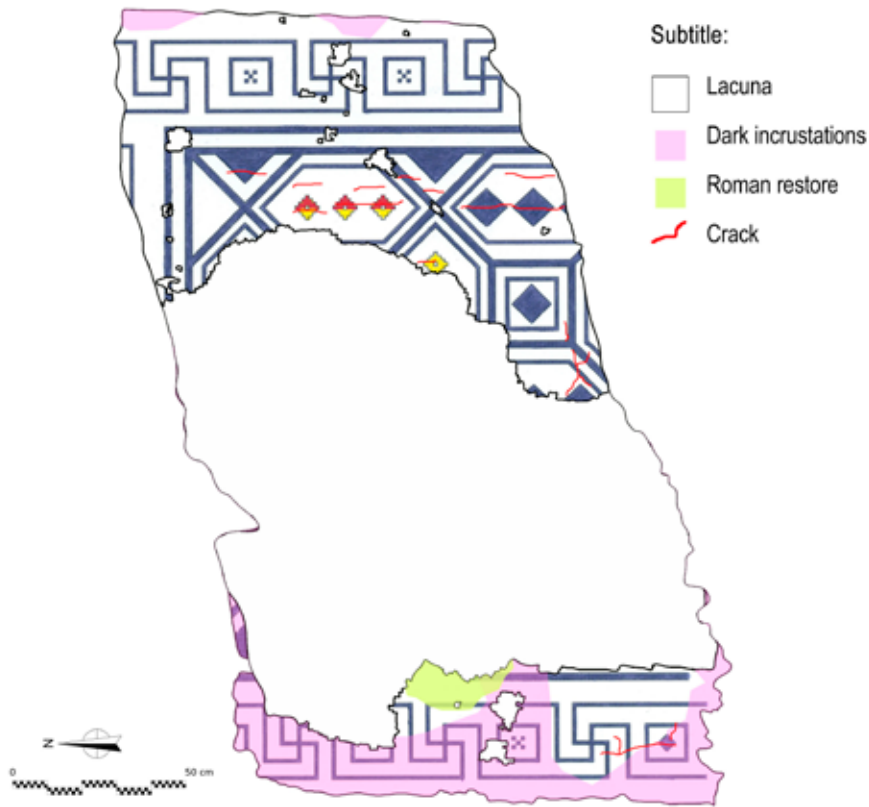
Figure 23
Mapping of the state of conservation, extension and damages of "mosaic 4".

This pavement, possibly a corridor, is in a reasonable state of conservation (Fig. 23). The fact that it is located at a low ground level has protected the pavement when the water ditch and road were built. However, it is possible to see some fissures, large gaps and several black incrustations, possible concretions formed during the deposition and burial process.

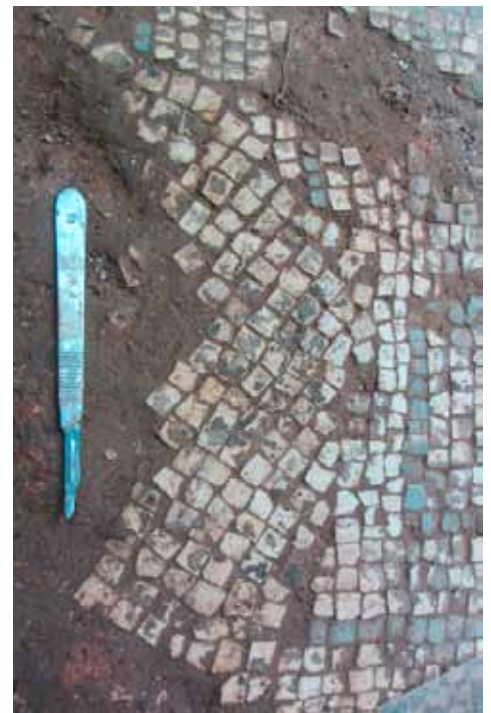
Figure 25
Mapping of the state of conservation, extension and damages of "mosaic 5".

In mosaic found in 2015 is possible to observe a pavement in great state of conservation with a reduced number of gaps (Fig. 25). However, despite the precautions during the extraction process of the building materials, directly over the *tessellatum* of this pavement, the involuntary extraction of a fragment occurred which originated the occurrence of a gap.

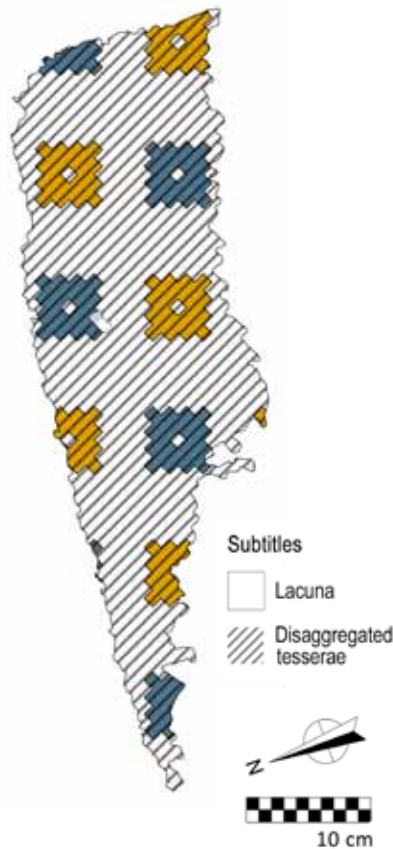
Figure 27
Mapping of the state of
conservation, extension and
damages of "mosaic 6".

The small fragment of this uncovered pavement revealed a good state of conservation (Fig. 27). However, it should be noted that there is a great disaggregation of the limestone that make up the *tesserae* of this pavement, especially in what regards the yellow *tesserae*, made of marly limestone, with high levels of porosity and more susceptible to both physical and chemical degradation (Fig. 28).

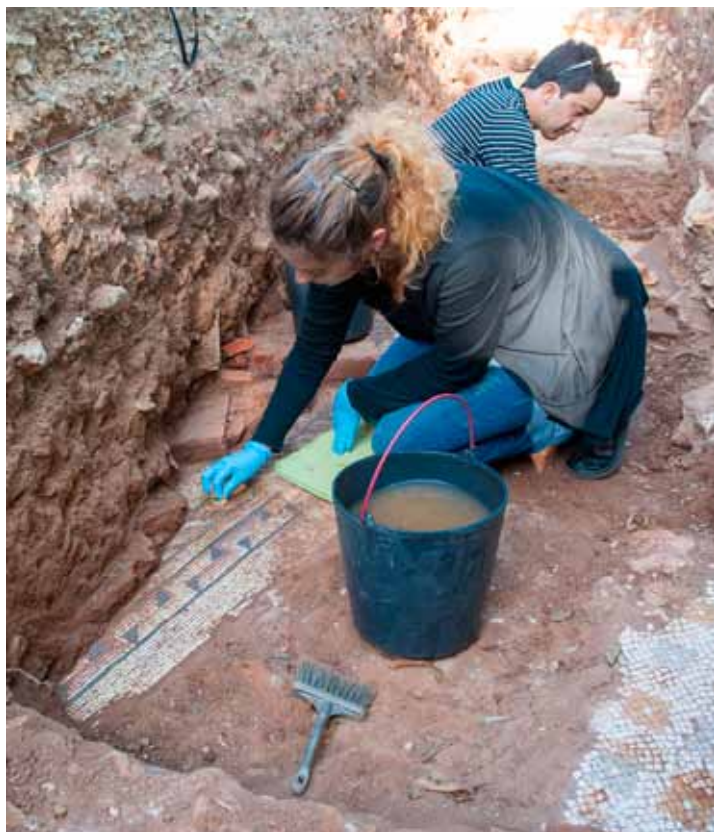
Figure 29
Surface cleaning of the *tessellatum*.

Regarding the intervention methodologies employed in the field, only preventive interventions were performed, necessary for the careful registration of the pavements (E.C.C.O. 2003). Thus, it was decided to eliminate earthy deposits on the surface through the use of mechanical means and sponges dampened with clean water (Fig. 29).

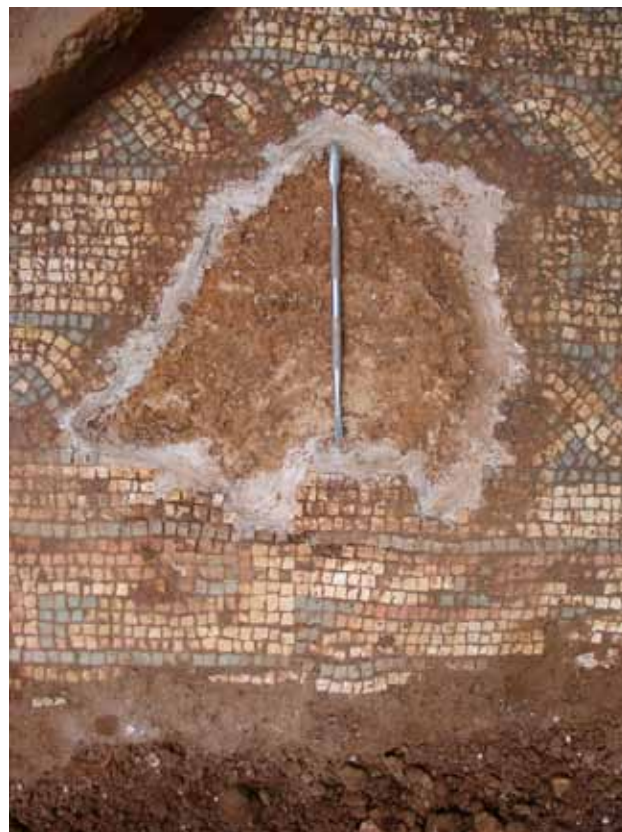
Figure 30
Limit consolidation of gaps.

Some procedures were occasionally performed to consolidate the limits of the gap areas, with mortar of a similar trace to the original one in order to avoid the decay of the *tessellatum* in these areas and the consequent increase of the gaps (Fig. 30).

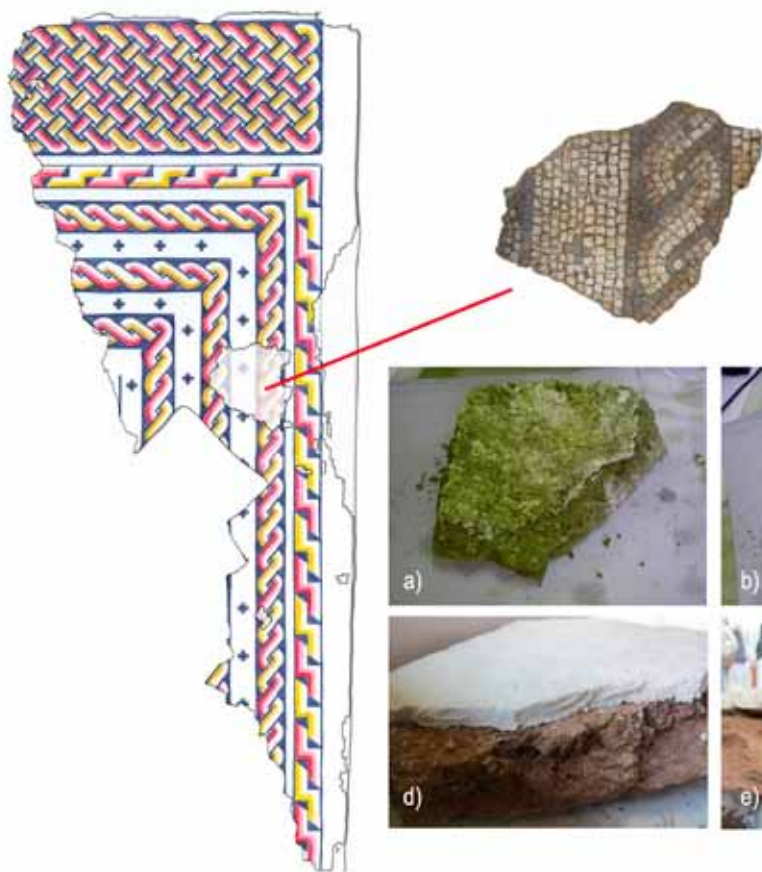
In the laboratory, it was necessary to proceed to the cleaning and stabilization of some mosaic fragments, by removing earthy deposits and deteriorated mortars (Fig. 31a-31b), and by consolidating the remaining mortars in the interstices of the *tesserae* (Fig. 31c).

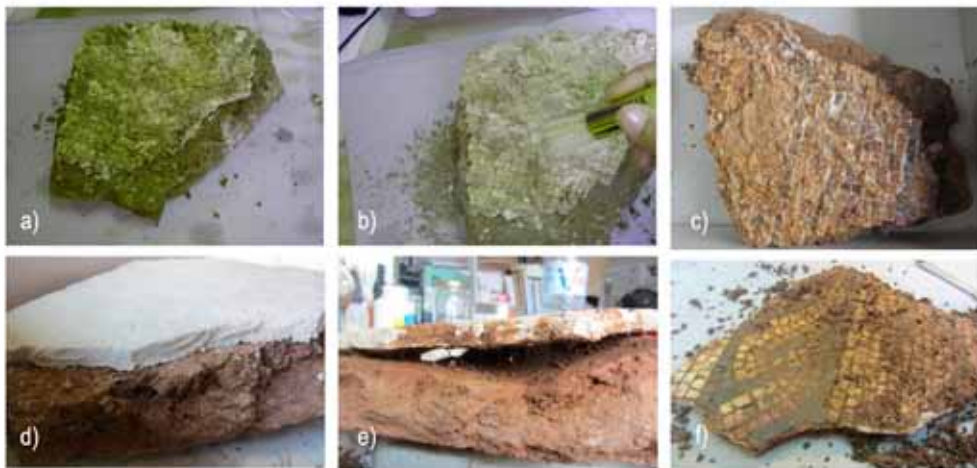
Figure 32
Protection of structures and
mosaic pavements.

Taking into account the principle of *in situ* conservation, future work continuity and the need to restore the use of the road to serve the residents, it was decided to rebury the structures and pavements. However, the improvement of the burial conditions was essential for a good conservation in order to avoid the direct contact with the excavation soil, composed of organic materials and soluble inorganic contaminants.
