Dynamic Identification of an Early 20th Century Civil Architectural Building

M. Bilal Bağbancı^{a*}

^aArchitecture Department, Architectural Faculty, Uludag University, Görükle-Bursa, Turkey.

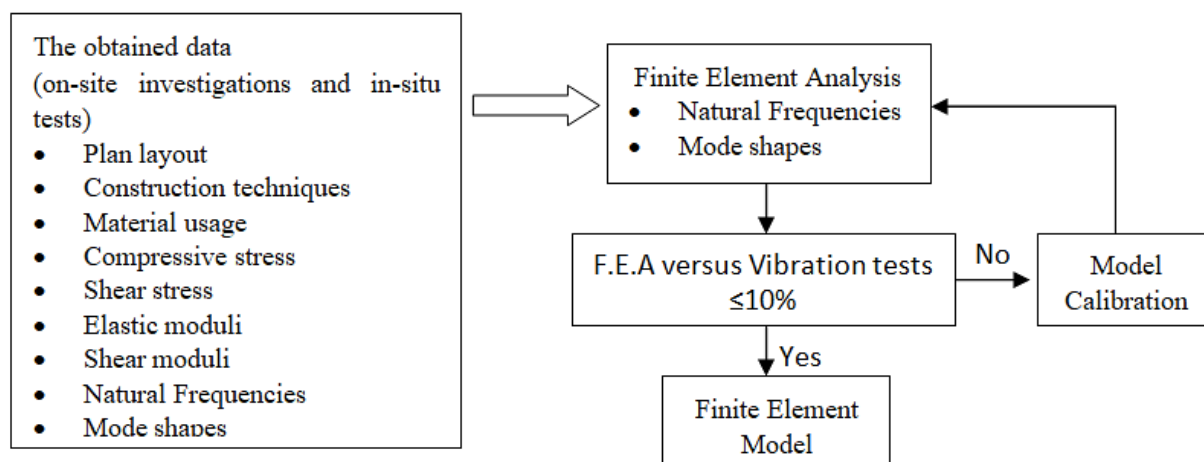
In this study, the plan layout, construction techniques and material usage of the building were investigated on-site and the mechanical properties such as compressive stress, elastic moduli and shear stress of the masonry walls were investigated by using in-situ flat-jack and shear tests. The dynamic characteristics such as mode shapes and natural frequencies of the structure were analyzed by using in-situ vibration tests. The OMA test method was used for determining the dynamic characteristics of the structure. The finite element model of the structure was prepared, and the modal analysis of the structure was performed by using the ALGOR finite element program. The finite element model calibrations were done by comparing the frequencies obtained from the vibration tests and the finite element modal analysis. The process was repeated until the difference was under 10% and the finite element model was formed at the end. The flowchart of the study is presented in Figure 1.

Figure 1. The flowchart of the study

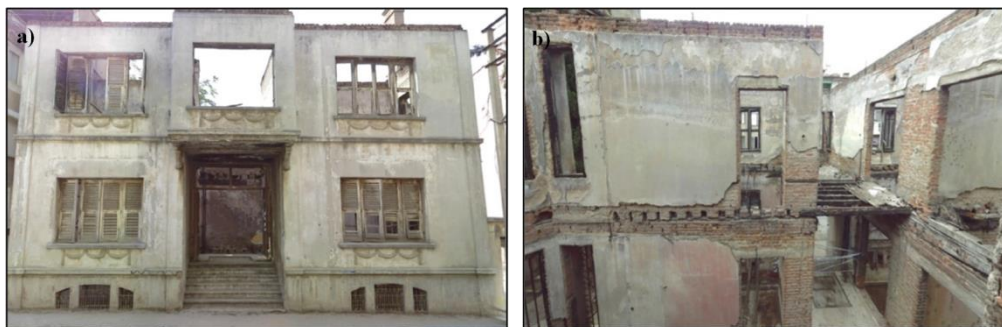
The house gained its importance with the hosting of Mustafa Kemal Atatürk in 1934. The construction of the house began in the first quarter of the 20th century according to the architectural features. After it was exposed to a fire in 1991, the house was unavailable for use (Figure 3). Timber beams, timber slabs and the roof of the building collapsed after the fire.

Figure 3. The studied building a) Outside view of the building b) Inside view of the building

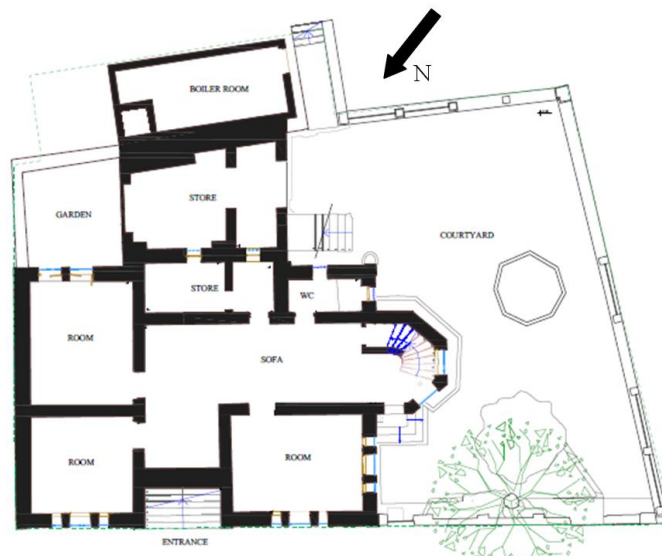
The house has three storeys; basement, ground floor and first floor. The house has a courtyard. The basement height is 2.10 m, while the ground and first floor heights are both 3.50 m. The basement floor plan can be seen in Figure 4.

Figure 4. The basement floor plan of the building

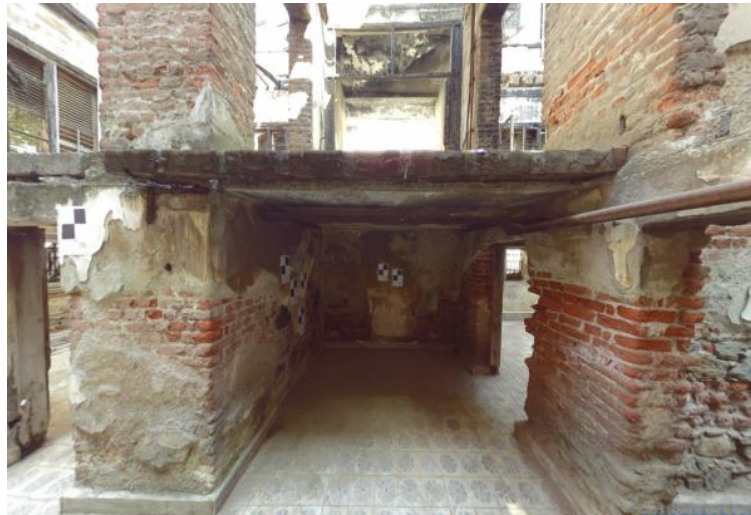
The walls of the building were constructed using brick material. Lime mortar was used as a binding material. Brick was used in the interior and exterior walls. The wall thicknesses are different for the exterior and interior walls. The exterior wall thicknesses are 50cm in the basement, and 40cm in the other storeys. The interior wall thicknesses are 45cm in the basement, 30cm in the ground floor and 25cm in the first floor. Two different techniques were used in the slab constructions. Timber slab was used in the living areas, while reinforced concrete slab was used in the wet areas and the entrance of the building. It is believed that these two types of slabs were constructed at the same time because there were no construction joints in the intersection of the walls, and the slab elevations are equal. Despite the fire, the reinforced concrete slabs are intact today (Figure 5).

Figure 5. The reinforced concrete slab in the entrance part of the building

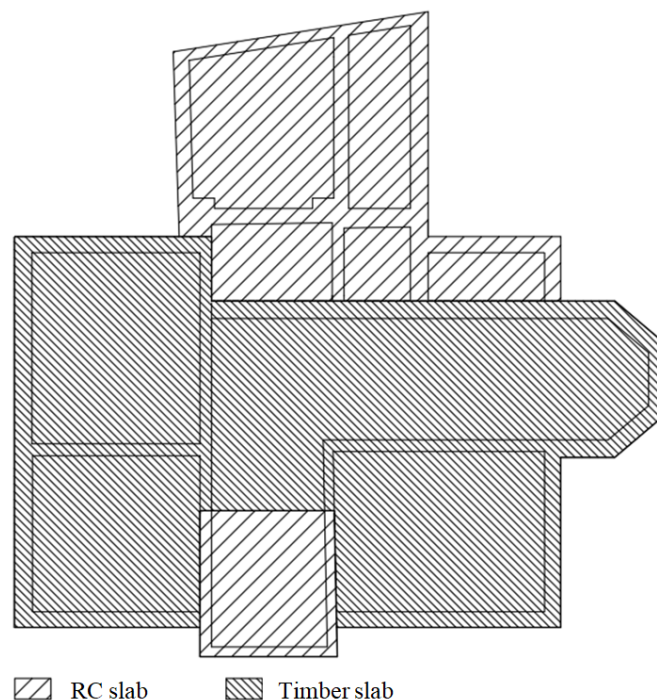
The reinforced concrete slab and timber slab usage in the construction of the building is shown in Figure 6.

Figure 6. The reinforced concrete and timber slabs of the building

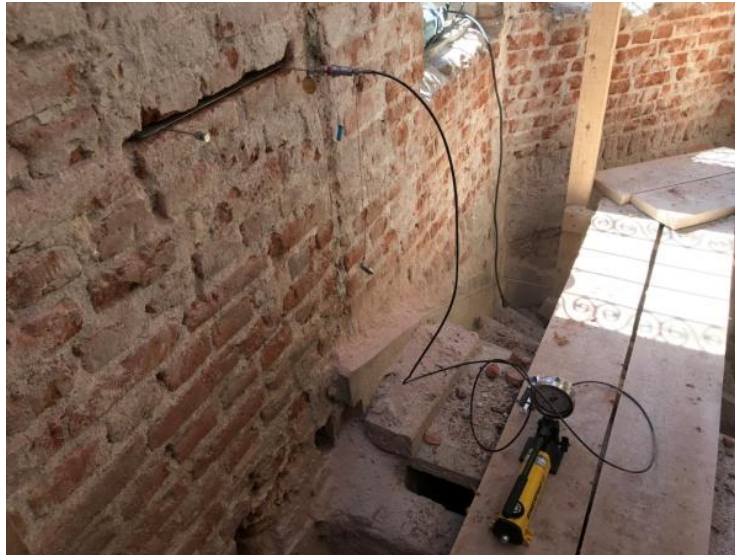
The mechanical properties such as compressive stress, shear stress and elastic moduli of the walls were investigated by using in-situ flat-jack and shear tests. The single flat-jack method was used for determining the compressive stress and elastic moduli of the walls. In this method, a flatjack is inserted in a cut slot in the mortar and displacements are continuously read while hydraulic oil pressure is inflated into the flatjack (Figure 7). The tests were conducted according to ASTM C1197 and ASTM C1314 [14, 15].

Figure 7. The mechanical tests: Single flat-jack test

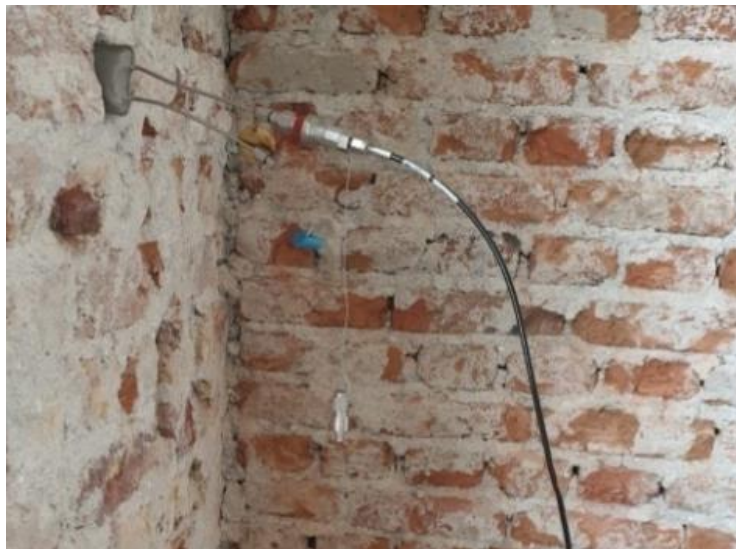
The method C was used in the shear test according to ASTM C1531-09 [16]. In this method, the flatjack is horizontally inserted at one end of the test unit (Figure 8). The oil pressure is applied until the slip of the mortar occurs.

Figure 8. The mechanical tests: Shear test

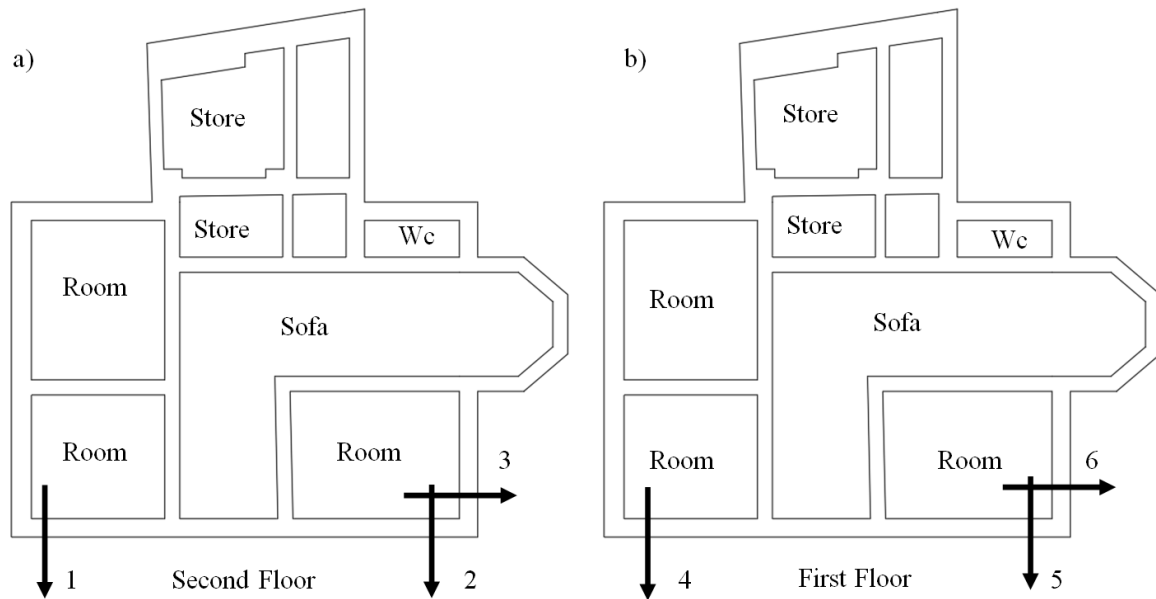
Acquisition/Structural Health Monitoring Device Testbox 2010 series data acquisition system was used in the study [17]. Six uniaxial accelerometers were used and for the accuracy of the tests, 20~30 minute test periods were applied. In the sensor placements, the perpendicular orientations were carefully checked for all walls. The sensors were placed on top of the first and second floor corners. Three sensors were placed on each floor. The orientations of the sensors on the plan view are shown in Figure 9.

Figure 9. The sensor orientations on plan views a) Second floor b) First floor

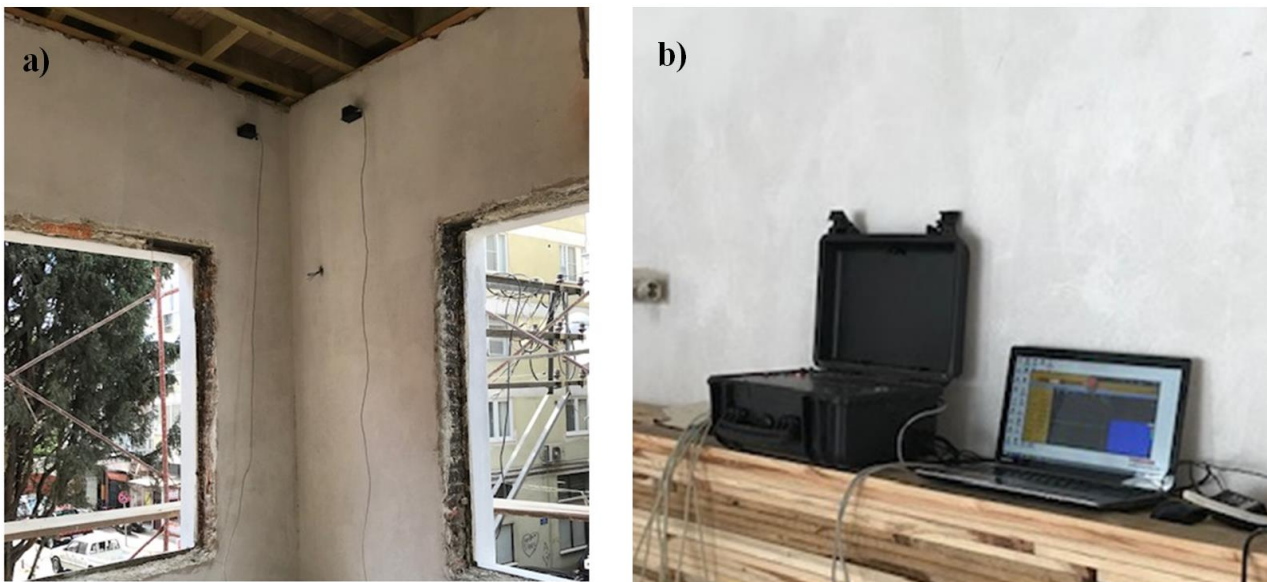
The placements of sensor number 5 and sensor number 6 on the second floor and the test equipment can be seen in Figure 10.

Figure 10. The sensor placements and the test equipment

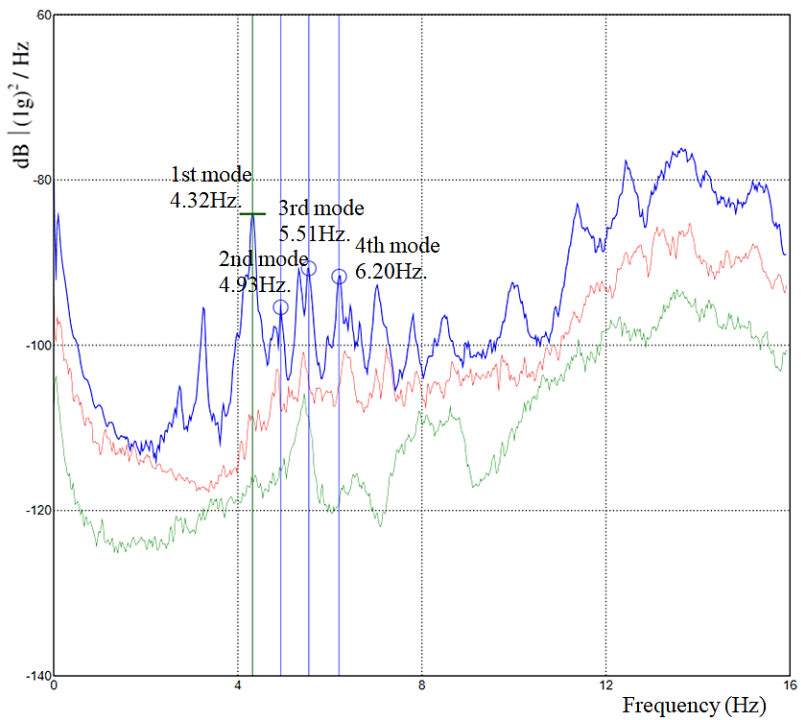
Frequency Domain Decomposition (FDD) was used in determination of the dynamic characteristics. The singular values of the spectral densities of the test setups are shown in Figure 11. The first mode frequencies can be seen in the figure.

Figure 11. The singular values of the spectral densities

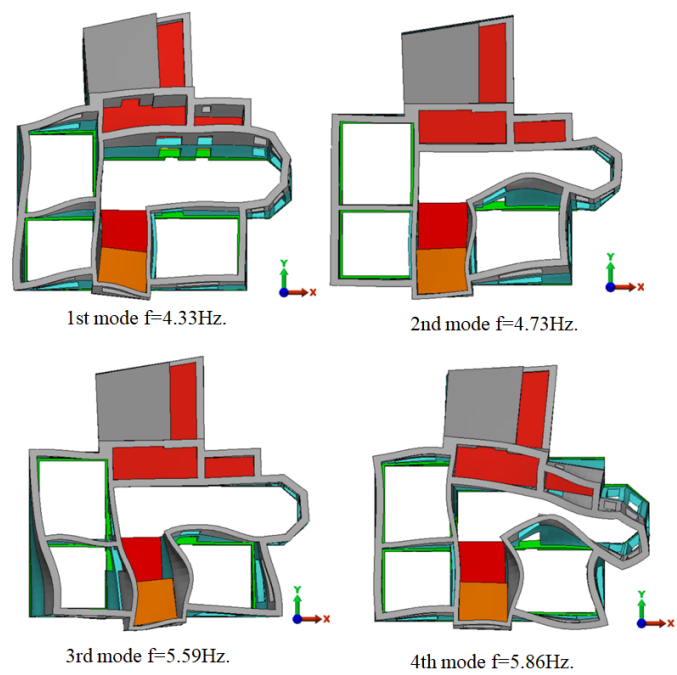
The elastic moduli of the walls were taken with an average of 2250 N/mm² after the calibrations. There is only an 18% difference between the flat-jack test results. The first four mode shapes and the frequencies are presented in figure 12. The first mode is the displacement in the y direction, the second mode is the torsion, the third mode is the displacement in the x direction and the fourth mode is the torsion.

Figure 12. The first four mode shapes and frequencies

The comparisons of the first four mode frequencies of the studied building between the vibration test results and the finite element analysis results after calibrations are presented in Table 2. It was determined that there was a maximum 5% difference between the frequency values. It can be stated that the finite element model of the structure now represents the real behavior of the structure correctly. Earthquake analysis, pushover analysis, and etc. can be done by using this model.
