Damages during February, 6-24 2017 Çanakkale earthquake swarm

Ramazan Livaoğlu¹, Mehmet Ömer Timurağaoğlu¹, Cavit Serhatoğlu¹, Mahmud Sami Döven²

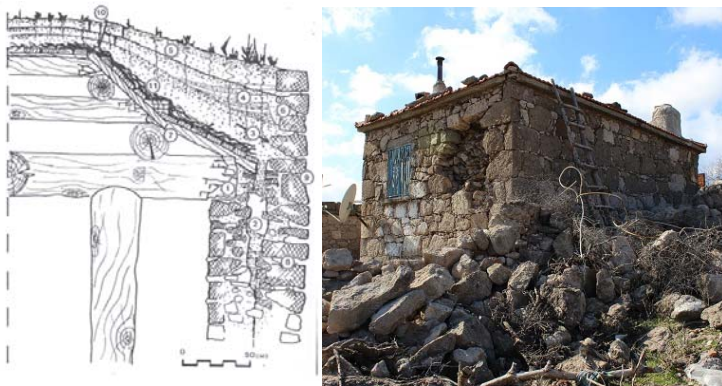
In Turkey, there are many different construction styles for supporting systems. More than 90% of these are reinforced concrete in city centres. However, traditional rural domestic style supporting systems are very distinctive; resulting from cultural attributes related to the availability of material and climate conditions of the building site. Timber is also one of the main materials preferred in building framed mansions and dwellings, especially in the Black Sea region of Turkey and in other hill/mountain side regions where timber is abundant. In any case, stone is a material that can be easily found, and lack of timber leaves people no choice but to use more stone in construction details. However, stone is not a convenient material in earthquake prone areas, because of its unit weight and being difficult to process. Timber also has an extensive history as a main structural “Hatıl” reinforcing element in rubble stone, brick and adobe houses, the predominant types of houses for ordinary people especially in rural areas (Hughes, 2000) (Fig. 3).

Figure 3: Typical wall construction detail (Hughes, 2000) and typical view of a dwelling from the region

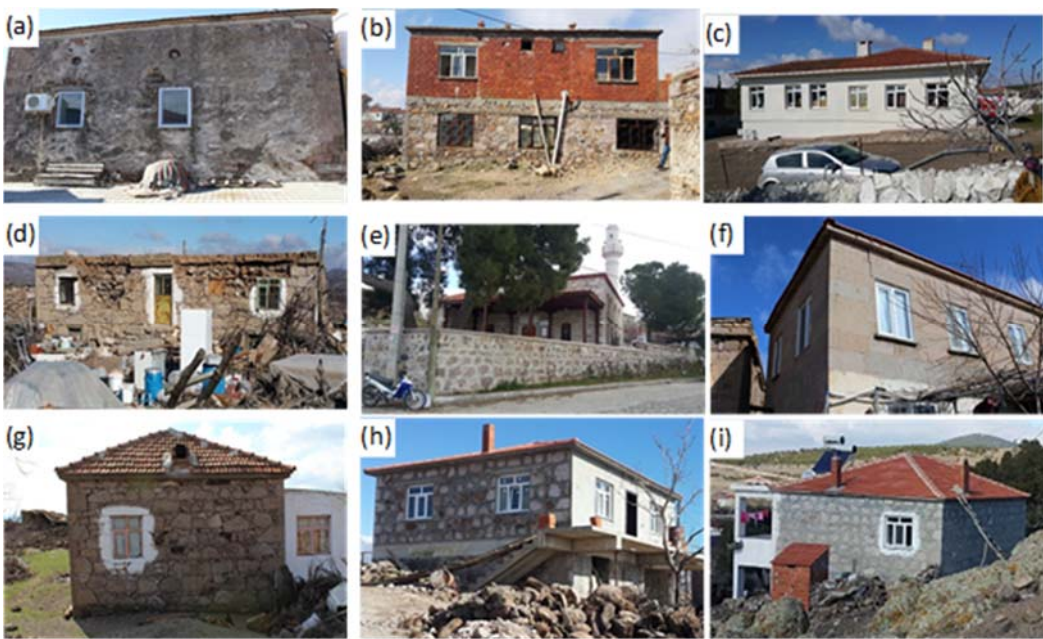
In the reconnaissance area, observations showed that the construction materials and skills were extremely deficient. Modern materials and techniques were only used in a small portion of the observed region. Moreover, cement mortar between stones was not used in almost 50% of the walls. There were a few buildings in which reinforced concrete elements were partly or fully used. Curing of concrete is still not practiced as an integral part of the concreting process. The concrete blocks are of poor quality because of poor quality of the concrete, lack of compaction and very little or no curing. The existing building types in the area are shown in Fig. 4.

15 **Figure 4: Existing building types in reconnaissance area: a) hatil dwelling b) stone and brick in cement mortar, c) engineered RC building d) hatil building with heavy roof, e) historical masonry with cut stone, f) cut stone without mortar, g) stone without mortar, h), i) stone in cement mortar with reinforced concrete.**

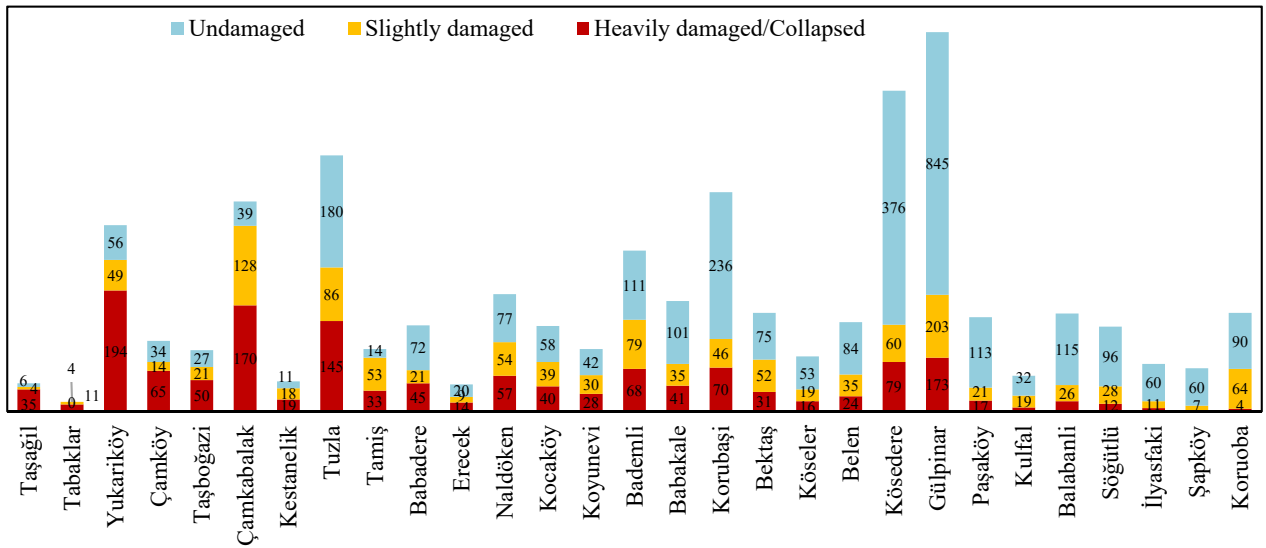
Figure 10: Number of buildings according to damage level due to Ayvacik earthquake swarm

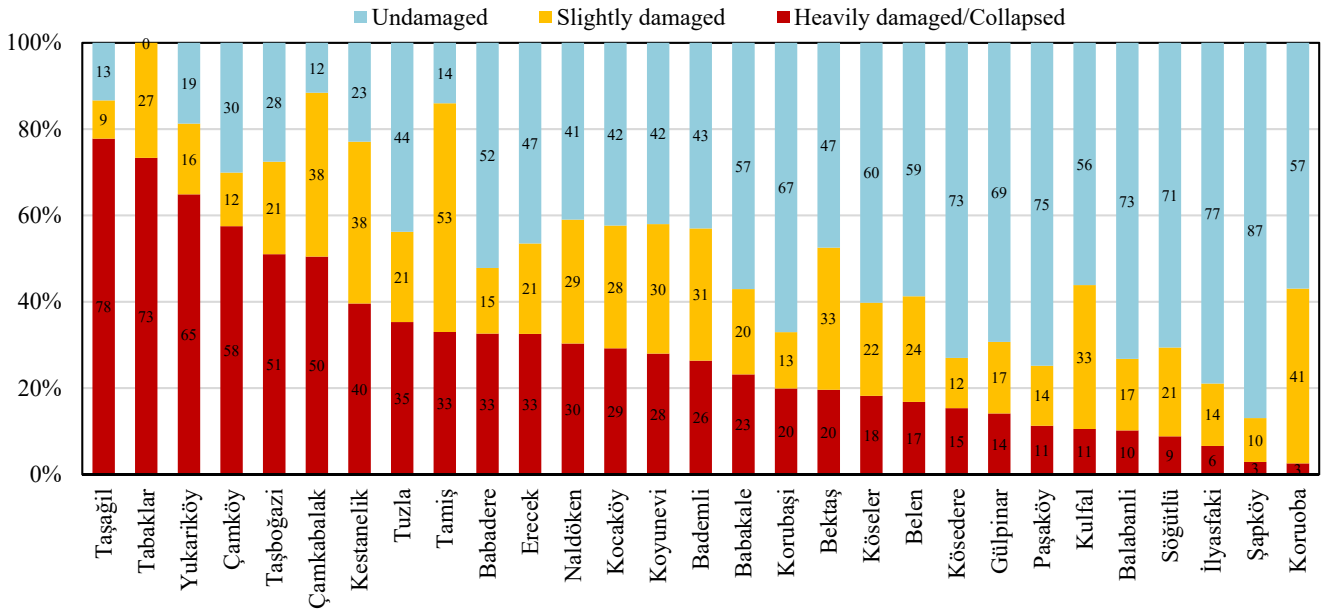
Since the energy release was relatively very small compared to the earthquakes that occurred on NAFZ or on EAFZ, the other
 10 most active zone of Turkey, no RC structures collapsed in the area other than the poorly constructed stone masonry dwellings in rural areas. According to the data obtained from Çanakkale Provincial Directorates of Environment and Urbanization, in twenty-nine villages, there were about 2705 damaged or collapsed buildings out of 5790 structures while 3083 structures did not suffer any damage. According to official estimates, within the affected area, a total of 1470 (25%) structures (including
 buildingsapartments, houses, barns, offices, stores and haylofts) were heavily damaged or collapsed, and 1235 (22%) structures
 15 suffered medium or minor repairable damage. Moreover, a total of 3083 (53%) structures did not suffer any damage. The locations of twenty-nine villages together with the epicentres of the studied earthquakes, their magnitudes, and PGAs are given in Figure 9, while the number of damaged structures and damage ratios within these villages are given in Figures 10 and 11, respectively. It can be seen from Figure 9 that Taşağıl, Yukarıköy and Çamköy, as well as Gülpınar are close to the epicentres of earthquakes, although structures located in the town of Gülpınar experienced significantly less damage than other villages

20 close to the epicentres (Figure 11). These results may relate to the construction techniques and development level of Gülpınar, which are more improved than the other villages.

Figure 11: Damage ratios in Villages according to damage level due to Ayvack earthquake swarm

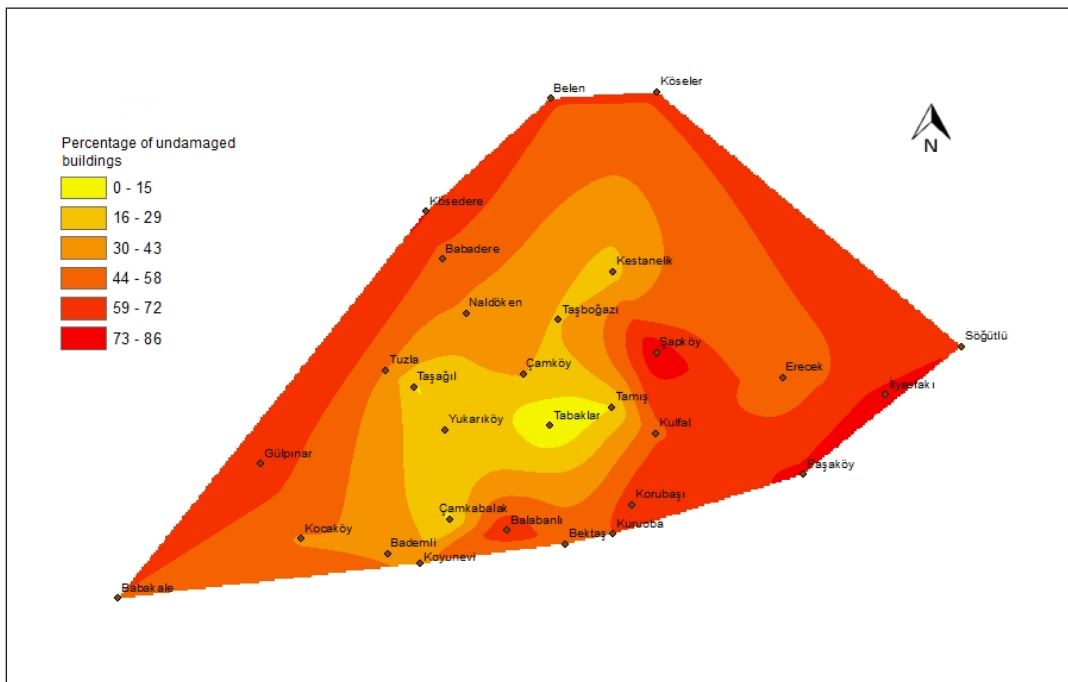
- 5 Distribution maps of buildings in percentages according to damage levels are given in Figures 12, 13 and 14, respectively. These figures clearly indicate that the percentage of heavily damaged/collapsed structures in Gülpınar was lower than other villages close to the epicentres that suffered significant damages. The reason for this can be explained by Gülpınar being a historical town centre in the region, therefore the town contain cultural heritage sites. The differences in terms of cultural accumulation and development level between Gülpınar and other villages subsequently affect the quality of construction. Thus,
- 10 structural damage was more prominent in the villages with relatively low economical development, and where there are no engineered buildings as observed by the authors.

Figure 12: Distribution maps of undamaged buildings in percentage

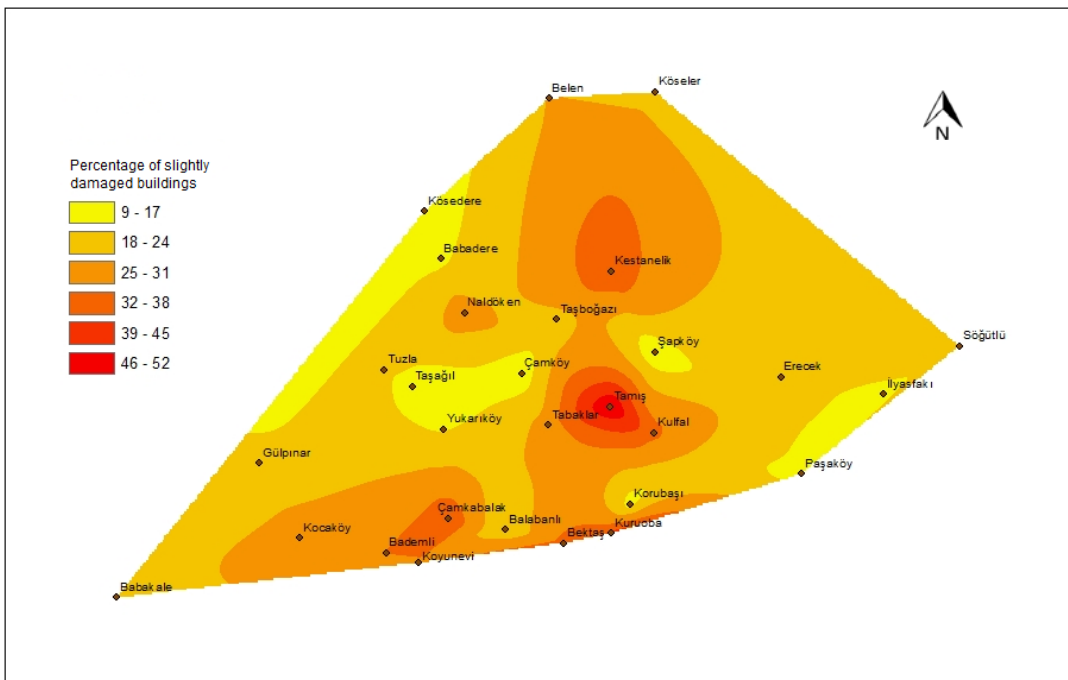
Figure 13: Distribution maps of slightly damaged buildings in percentage

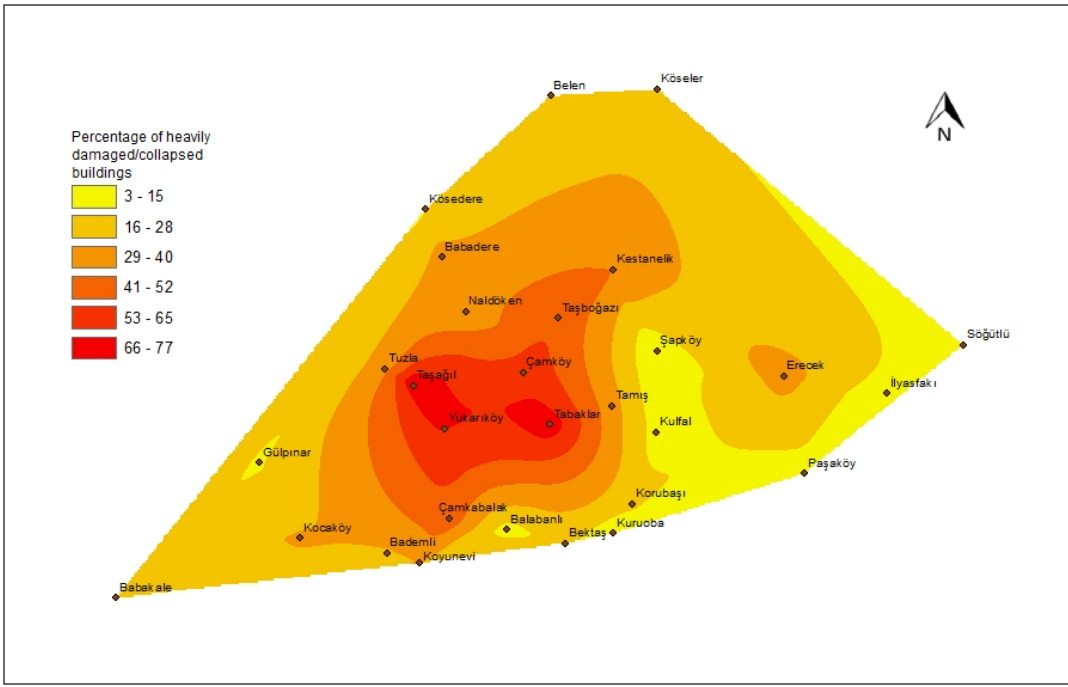
Figure 14: Distribution maps of heavily damaged/collapsed buildings in percentage

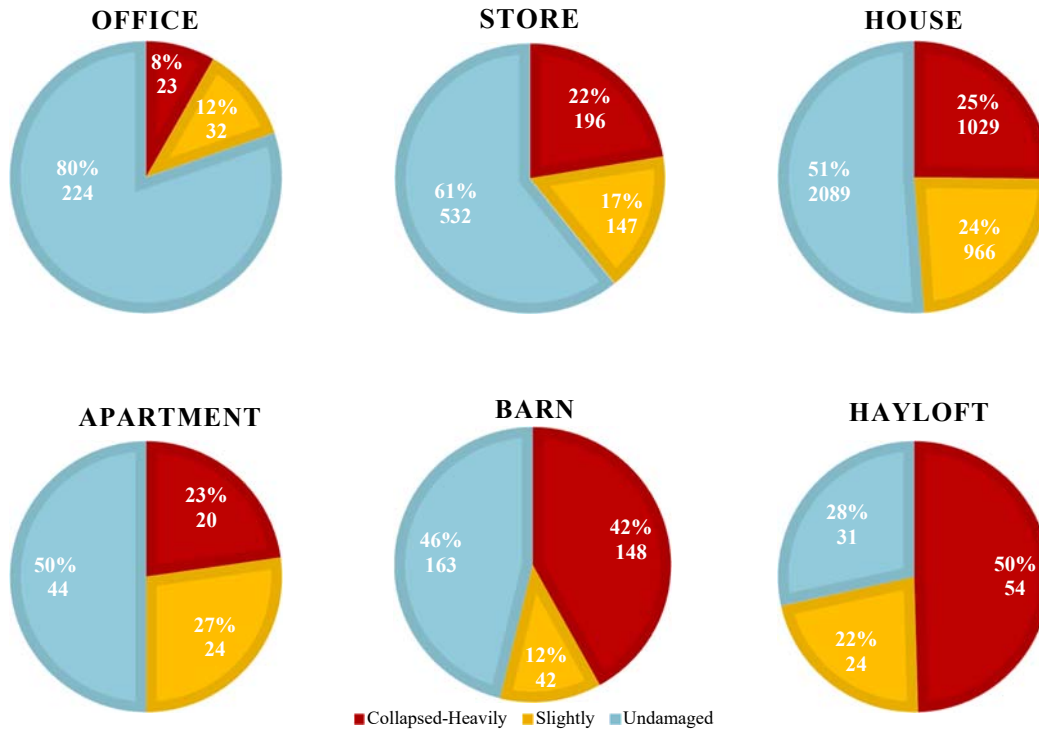
Distribution maps mentioned above are created for damage ratios according to damage levels of all structures for all structures regardless of the structure. However, evaluation of damage levels according to structure may introduce a new perspective in interpreting the damages. Besides, such a parametric study may be a guide in order not to repeat similar mistakes when reconstructing structures with a high heavily damaged/collapsed ratio according to structure. Damage ratios according to six structure are generated in Figure 15 with the support of Çanakkale Provincial Directorates of Environment and Urbanization. As can be seen from the figure, the construction practices applied on Haylofts and Barns should be substantially revised in order to minimize damages from a potential similar earthquake. Because most of haylofts and barns are constructed using stone without mortar and also net span between walls of the structures were great high. On the other hand, the techniques used on structures having a heavily damaged ratio of approximately 25%, such as stores, houses and apartments may be reviewed and enhanced according to technical deficiencies mentioned in the next section. It can be seen that office structures experienced relatively less damage compared to other structure. Thus, it can be said that construction of office structures was performed more in line with the conditions required by TEC' 2007.

Figure 15: Damage ratios and levels according to structure

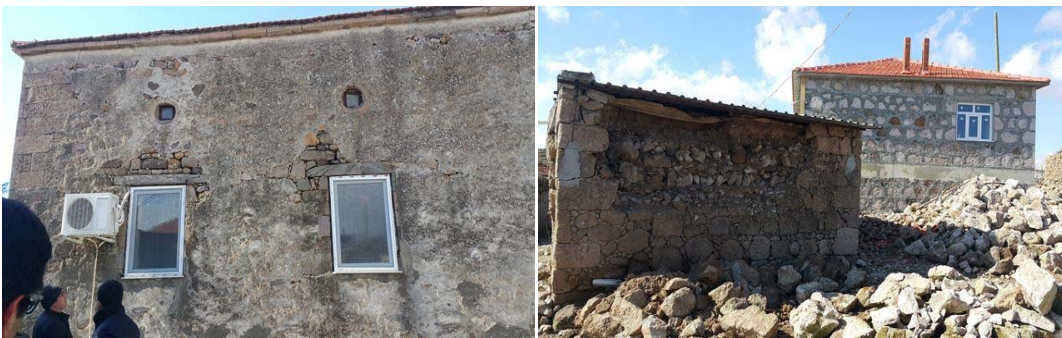
Figure 22: Examples of undamaged dwellings
